MADISON RIVER, MONTANA
REPORT ON
*FLOOD EMERGENCY
MADISON RIVER SLIDE*

*VOLUME I
MAIN REPORT*

U. S. ARMY ENGINEER DISTRICT, OMAHA
CORPS OF ENGINEERS
OMAHA, NEBRASKA
SEPTEMBER 1960

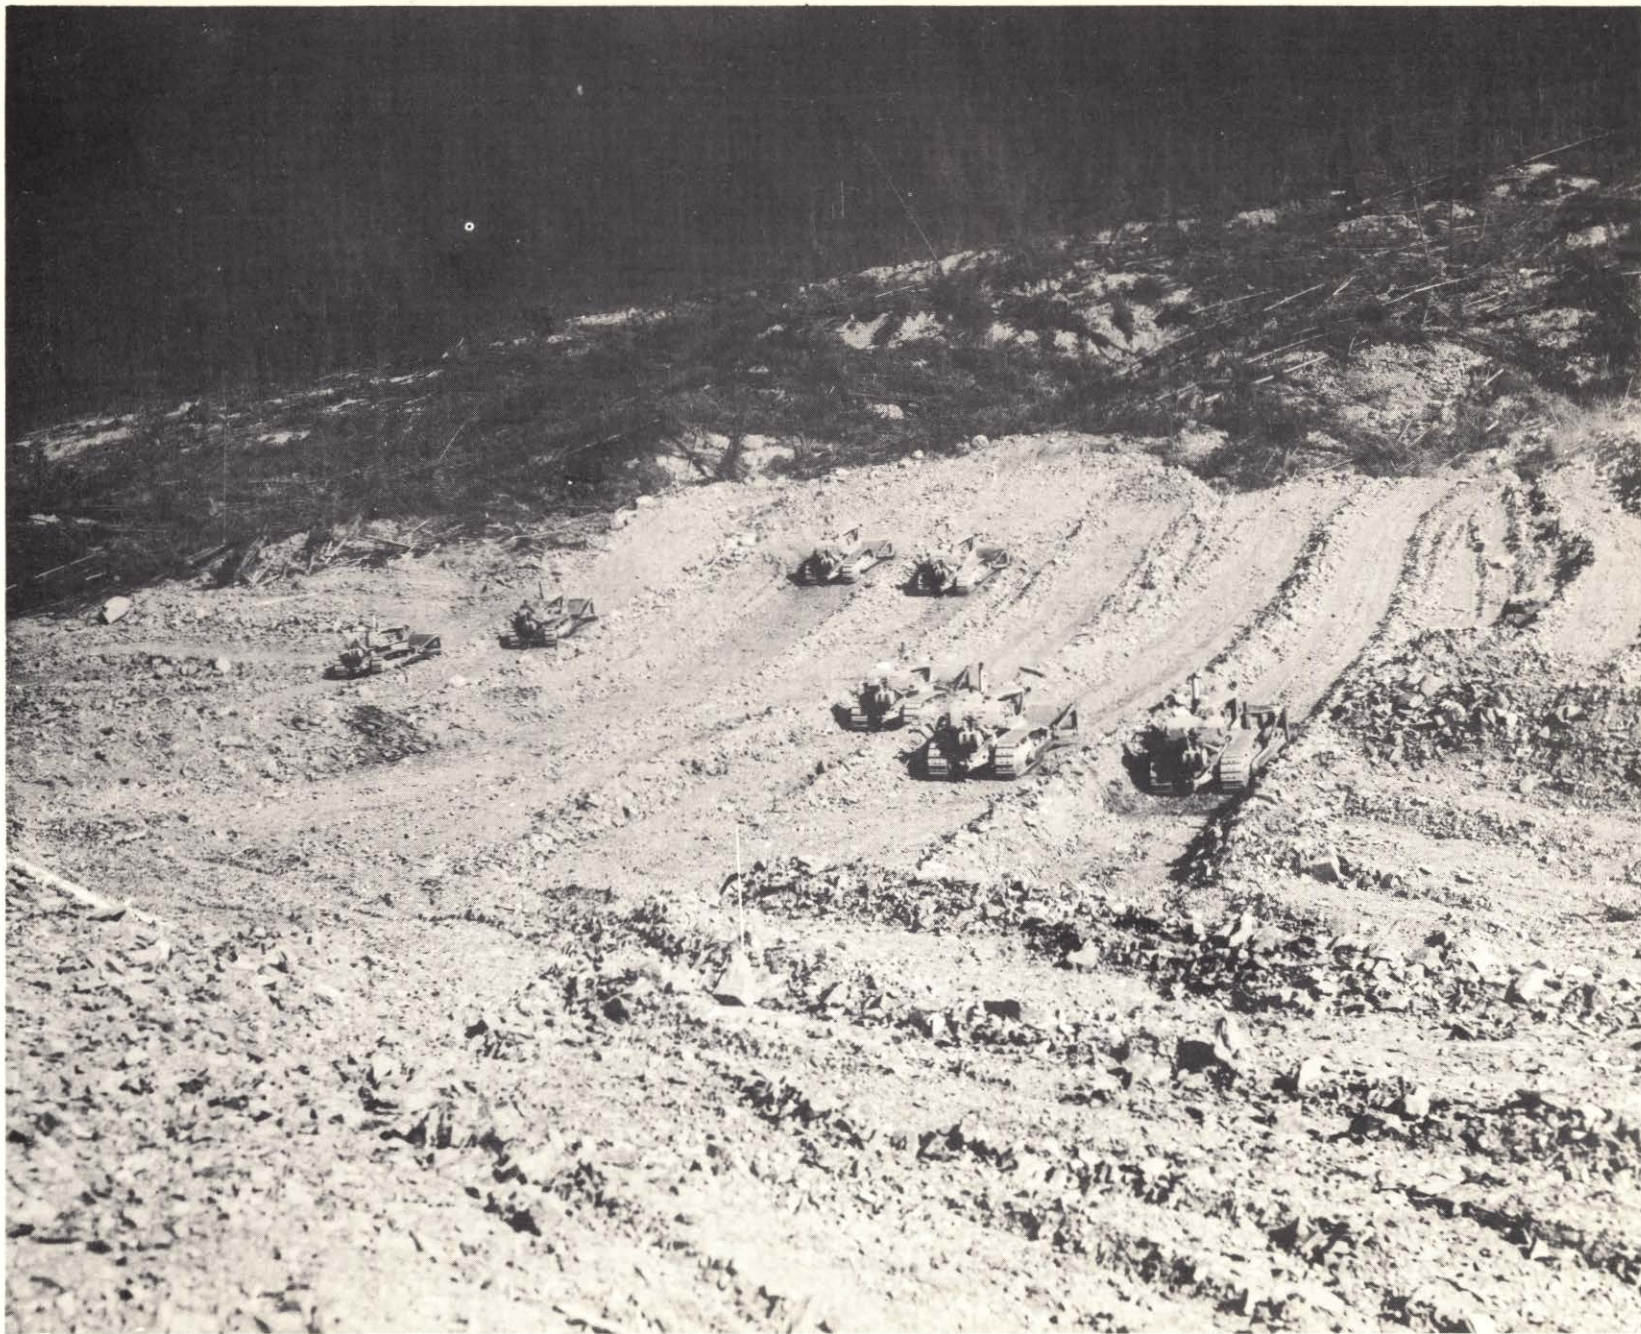
Photo 3. 27 August 1959. Bulldozers grading slide crest.

42. By the end of August, the level crest of the spillway was essentially completed to finish grade and most of the dozers were working on the downstream slope. Shovels and trucks were used to move some of the material, particularly along the right side of the channel at the crest. Typical views of these operations are shown in Photographs 3 and 4.

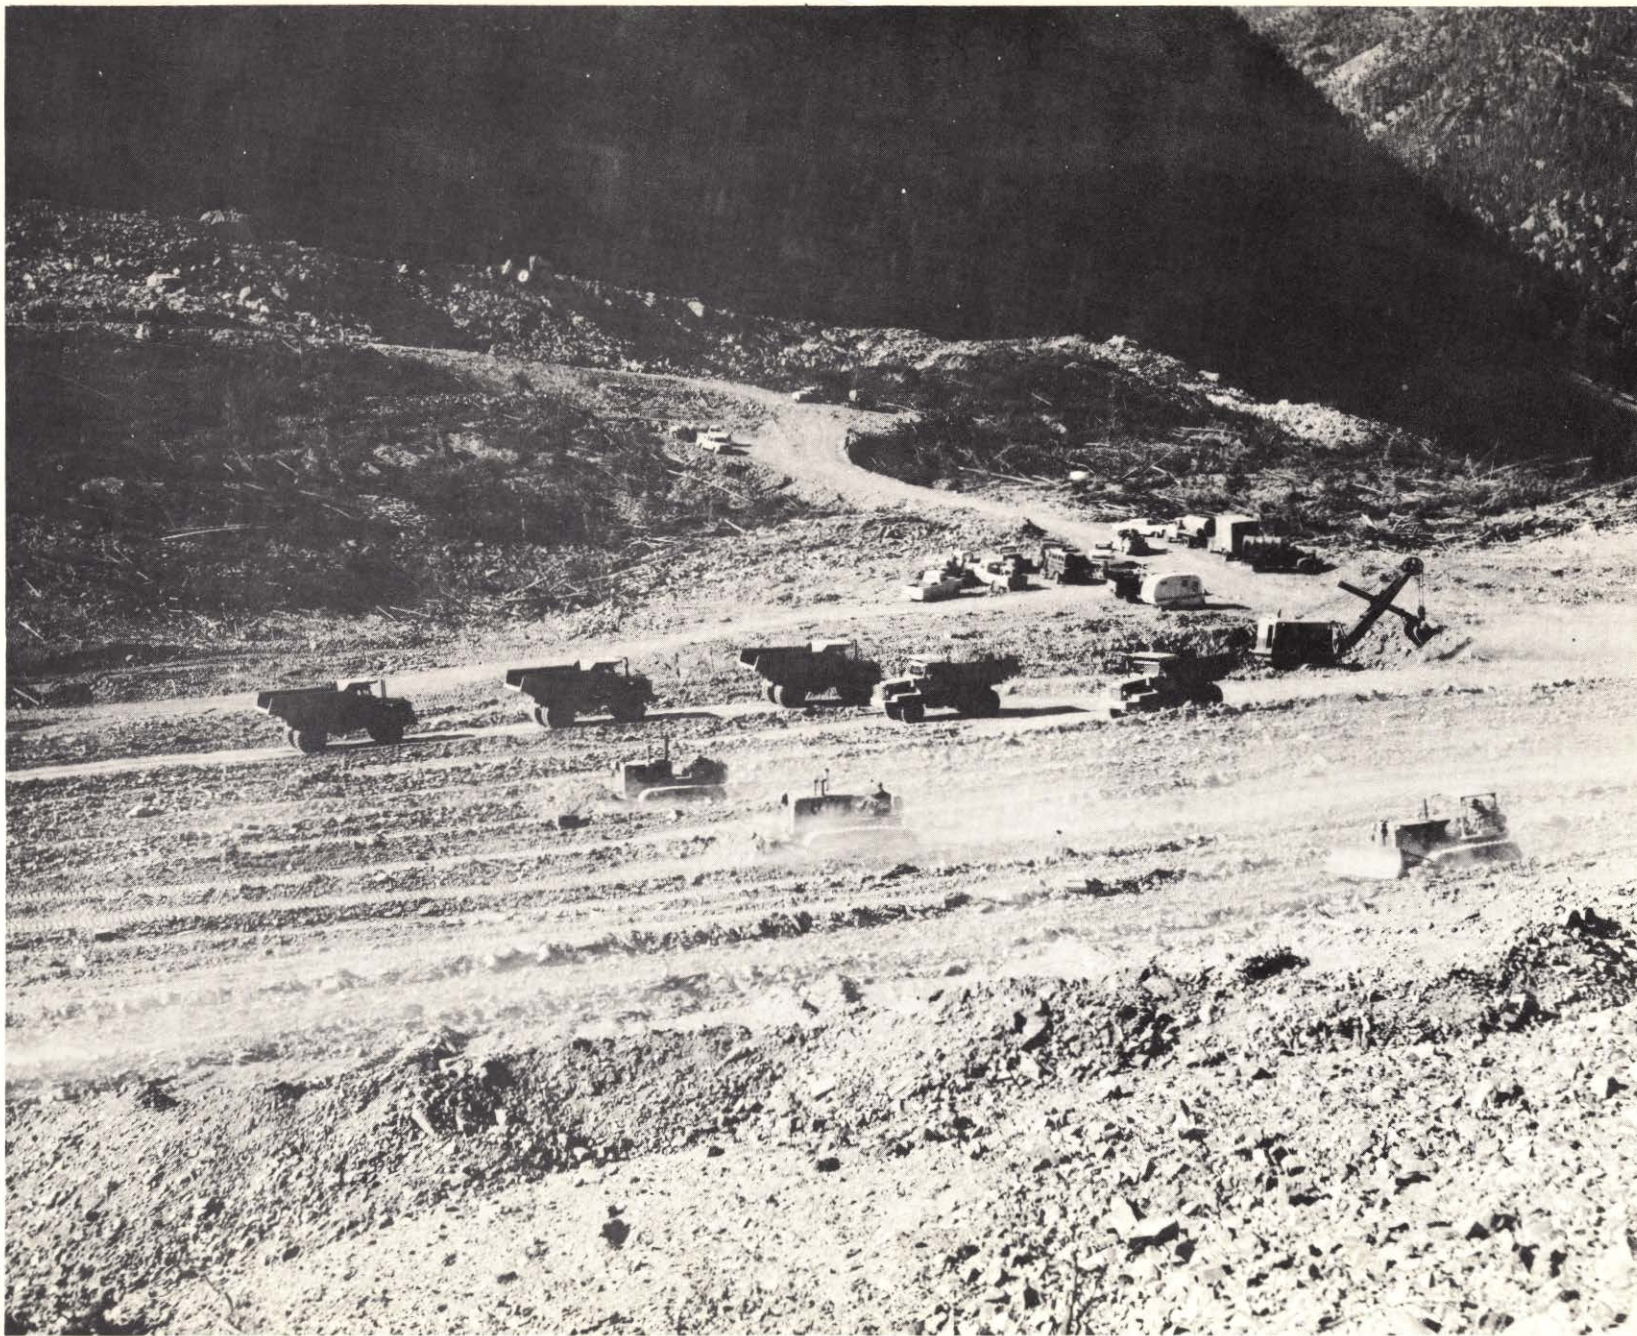
Photo 4. 28 August 1959. Equipment constructing initial spillway.

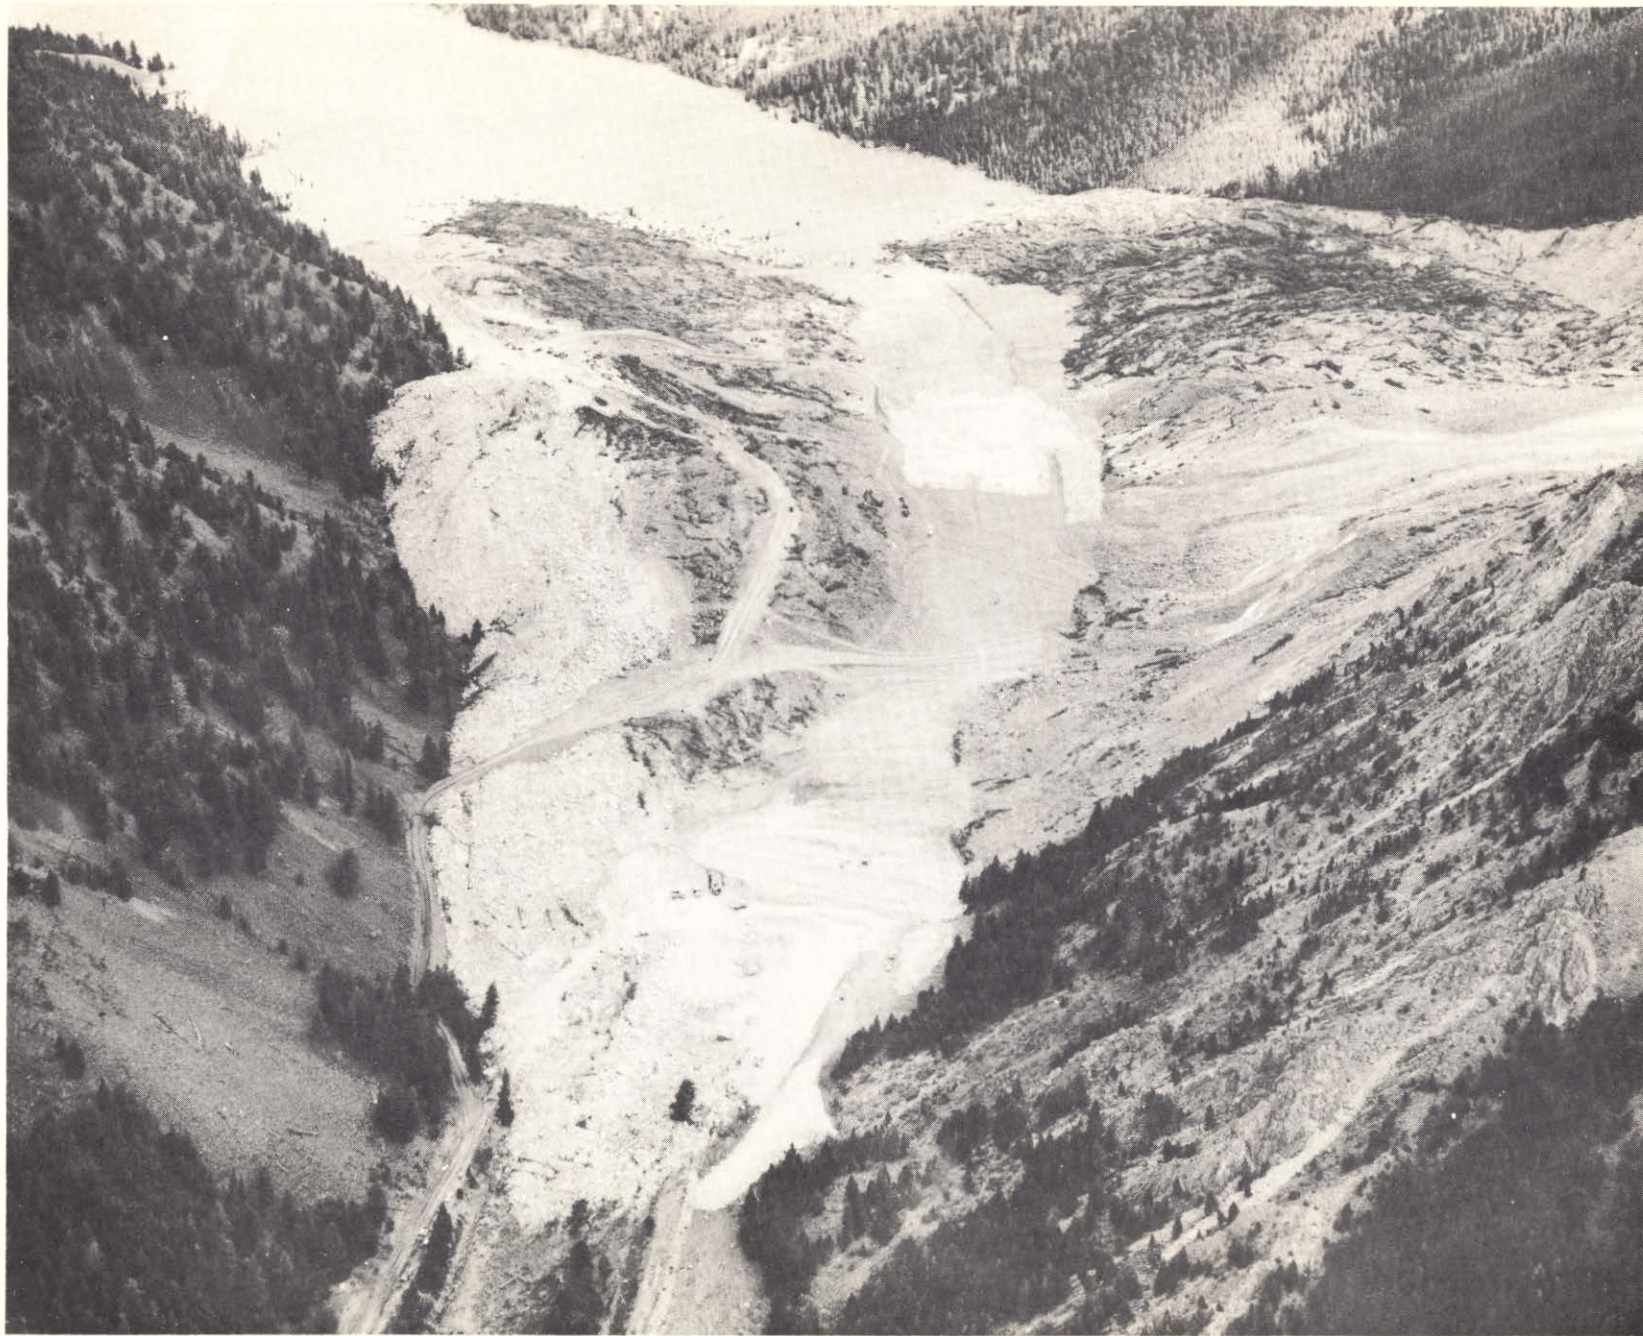
Photo 5. 3 September 1959. Aerial view of initial spillway construction.

40. Initial Spillway. In the first phase of spillway construction, the channel was excavated to a crest elevation of 6450, with a bottom width of 250 feet, and the left side and part of the downstream slope was lined with the best material that would be found in the slide. The white rock showing in Photos 5, 6 and 7 is the more competent Dolomite rock placed as channel lining. The excavation in the crest area was almost entirely a bulldozer operation. The upstream ridge, which was the highest of a series of ridges across the saddle, was cut off and the material pushed to the upstream slope. To minimize the possibility of losing control of the crest by an upstream slide, a large pocket just downstream from this ridge and about 50 feet lower in elevation was filled to an elevation about 20 feet below design crest elevation with the relatively fine material dozed from the ridges. The top 20 feet was filled with heavy quartzite borrowed from the layer on the right canyon wall.

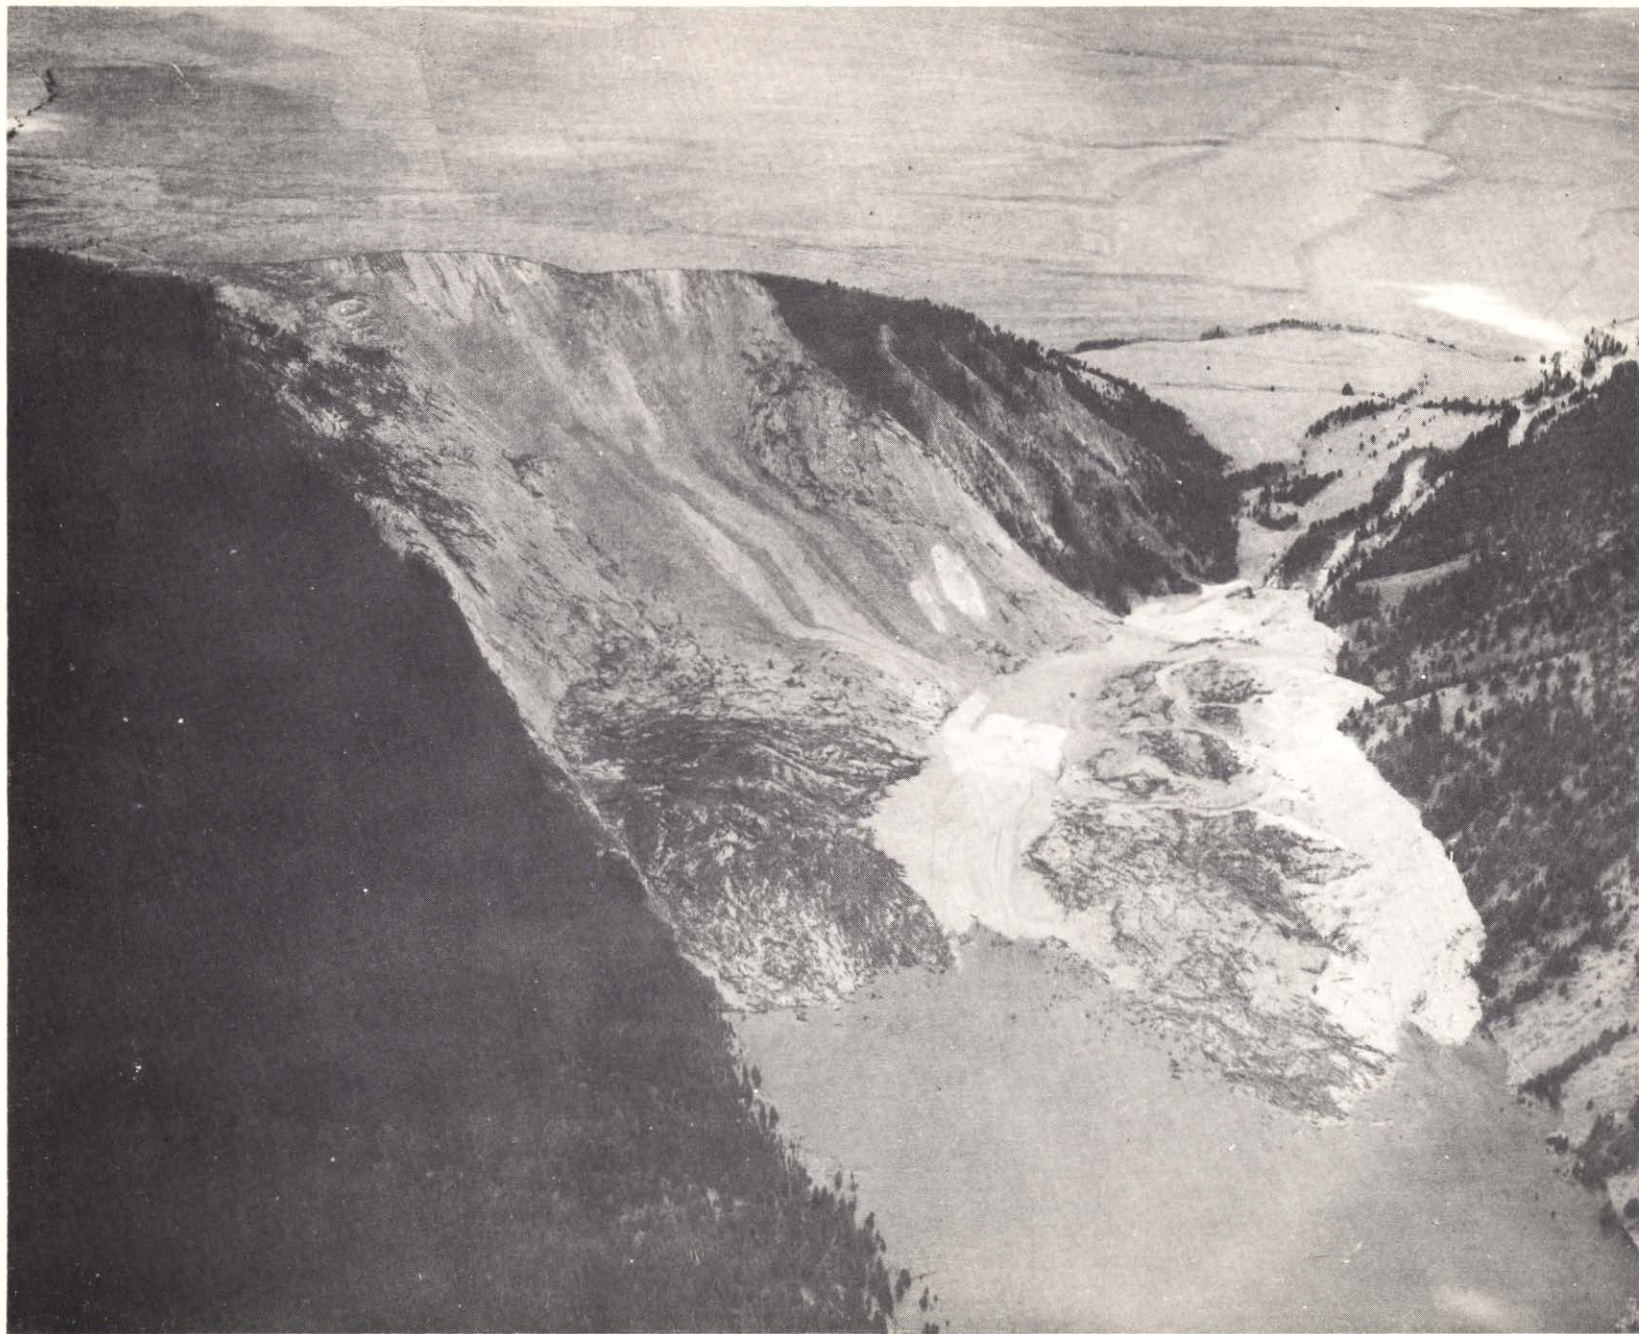
Photo 6. 3 September 1959. Over-all aerial view looking downstream showing initial spillway construction and a view of the slide scar.

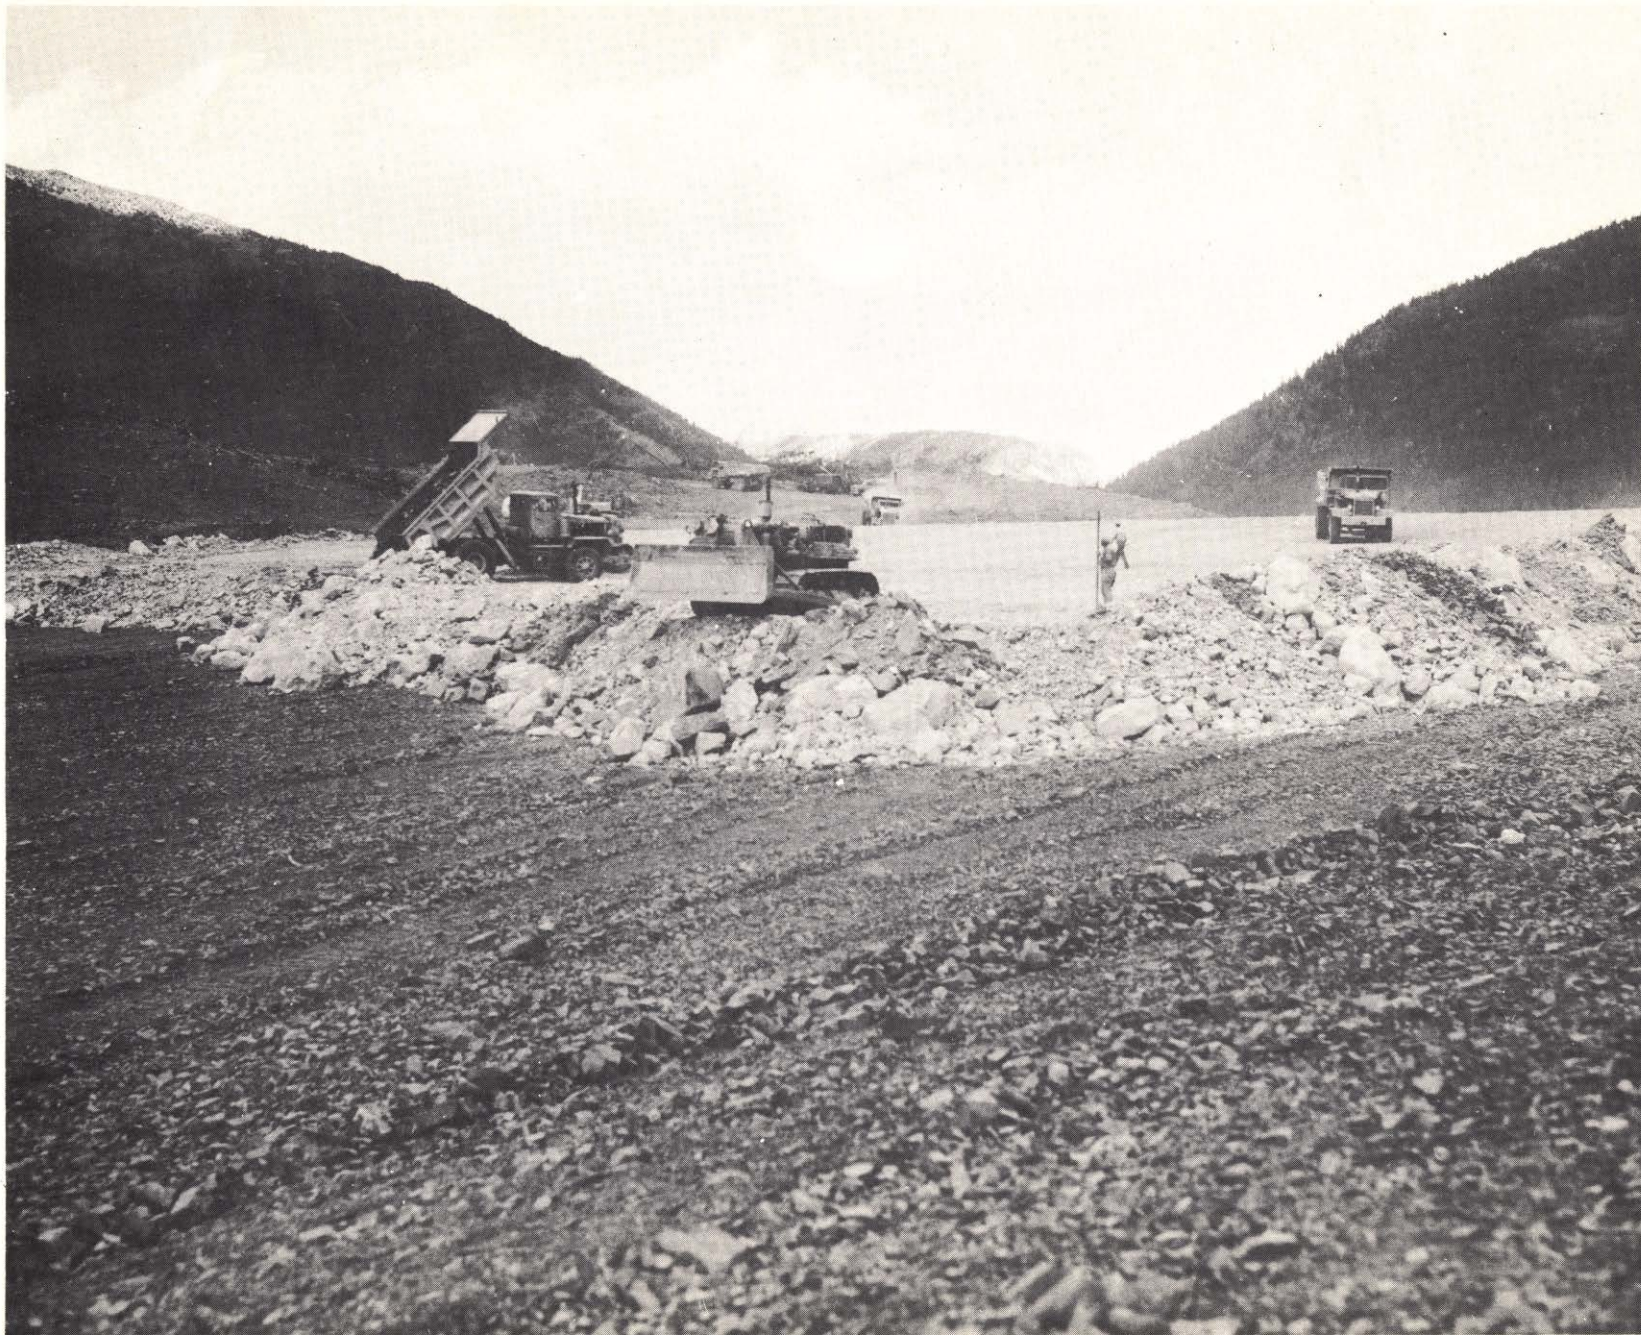
Photo 7. 4 September 1959. Placing spillway armor material in channel.

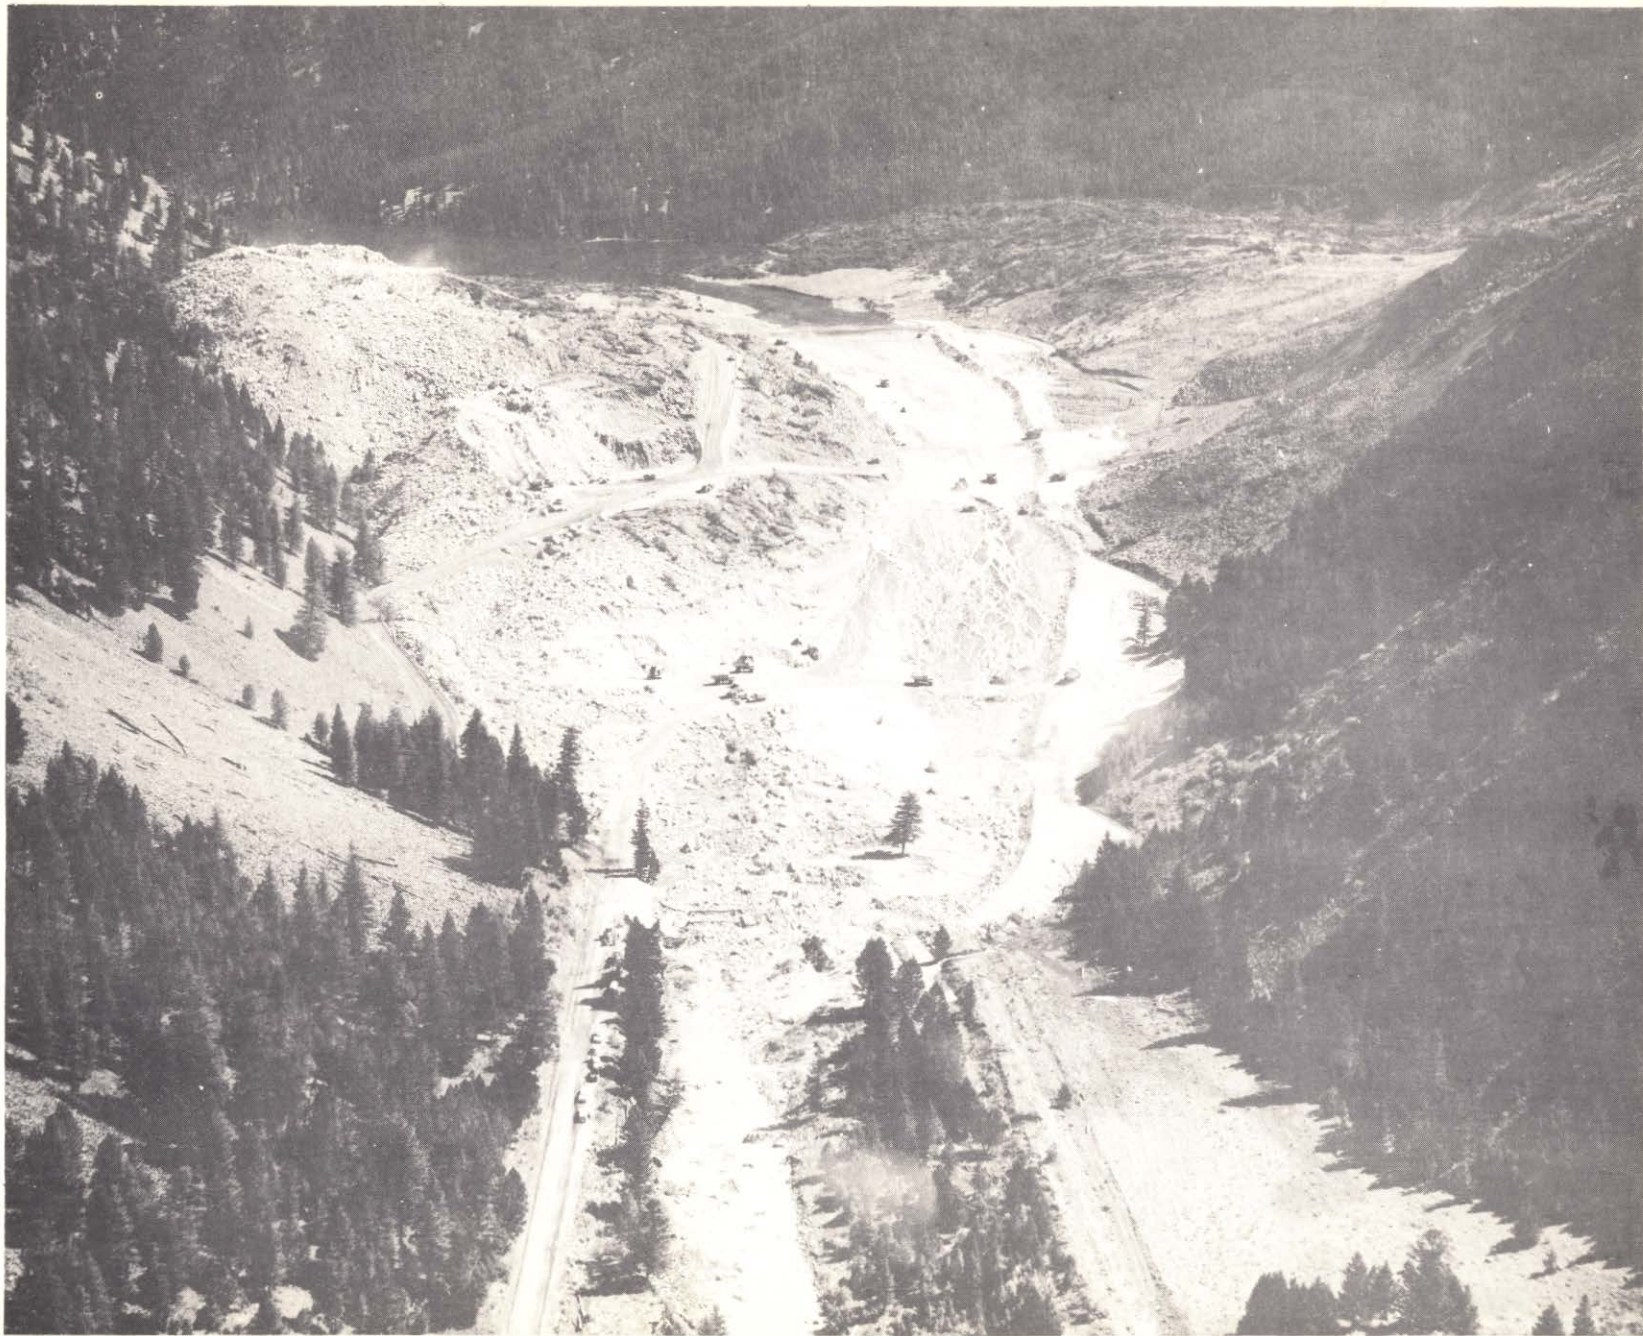
Photo 8. 10 September 1959. Upstream aerial view of spillway channel on first day water passed over slide.

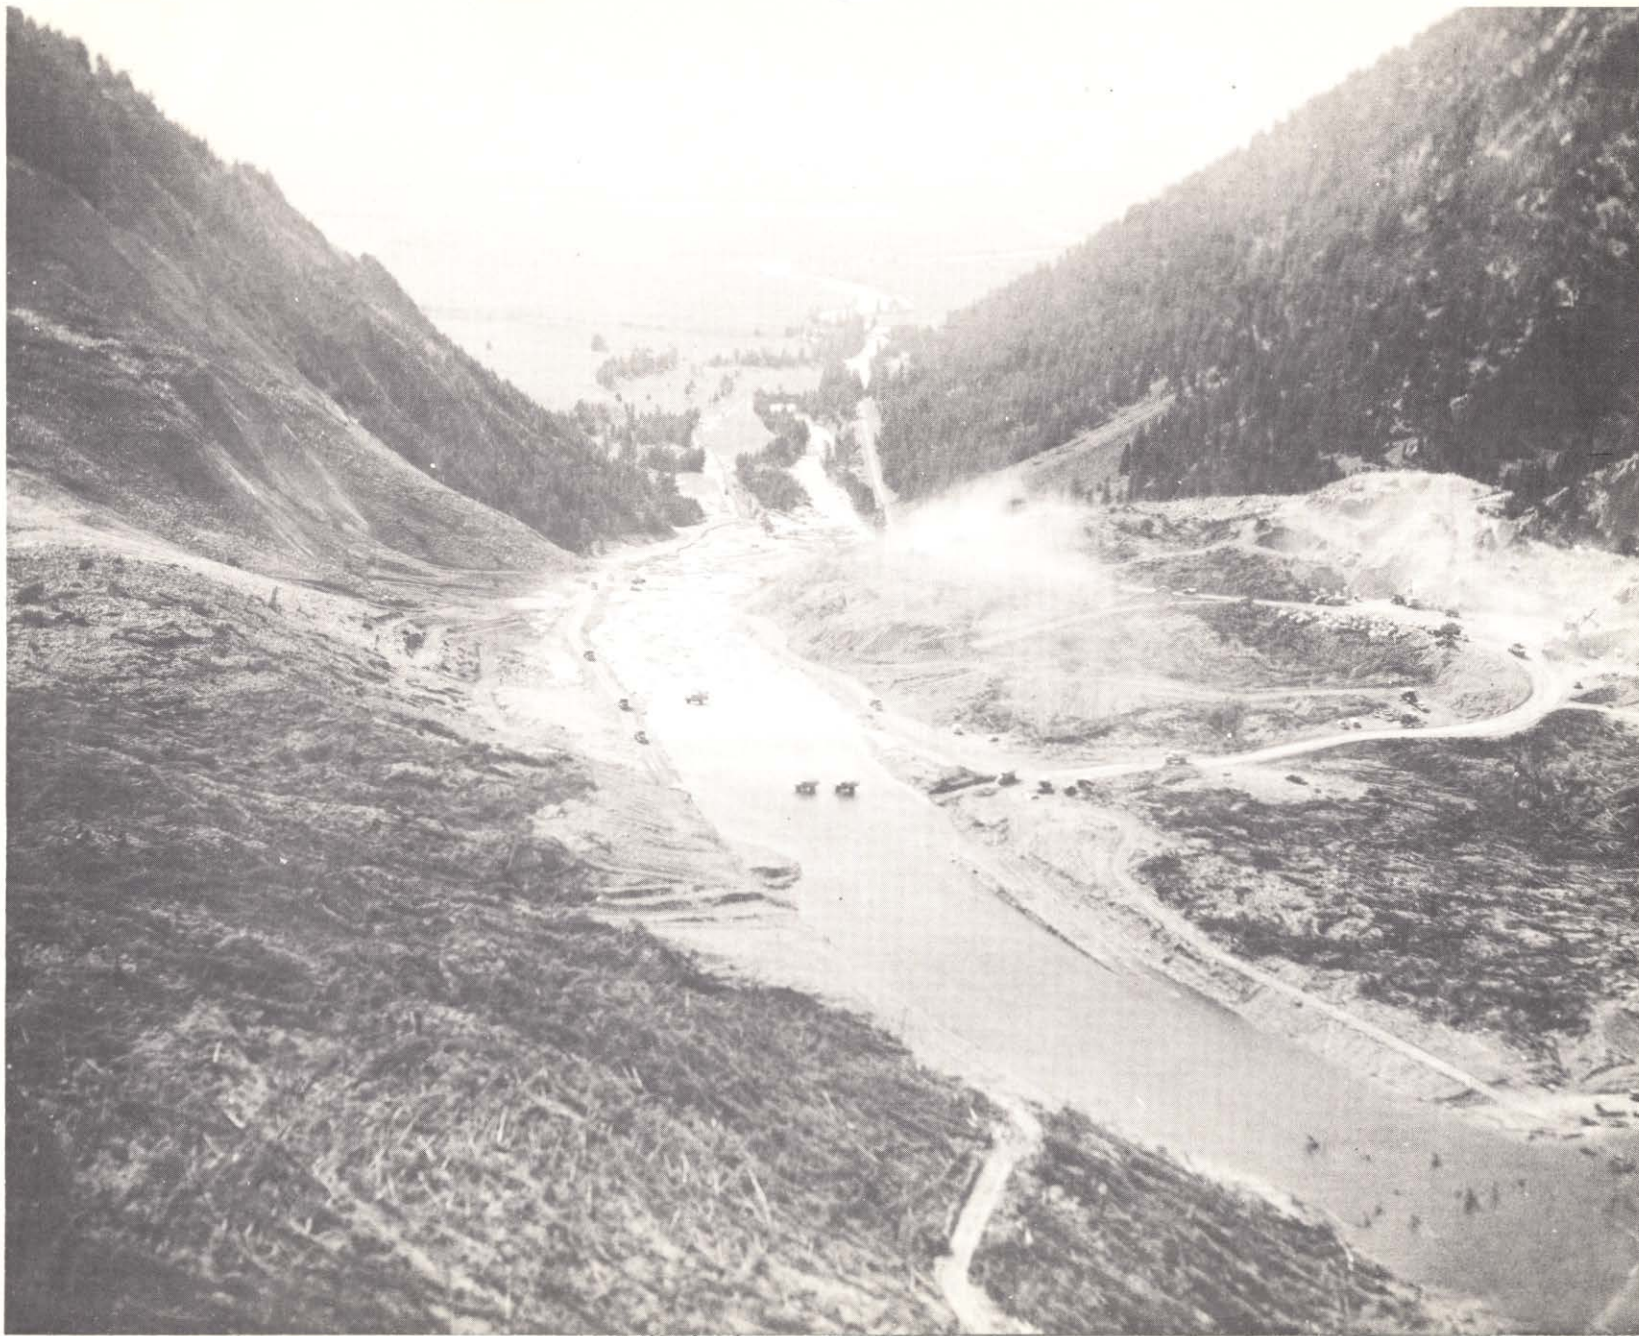
Photo 9. 11 September 1959. Downstream aerial view of water passing over slide in spillway channel.

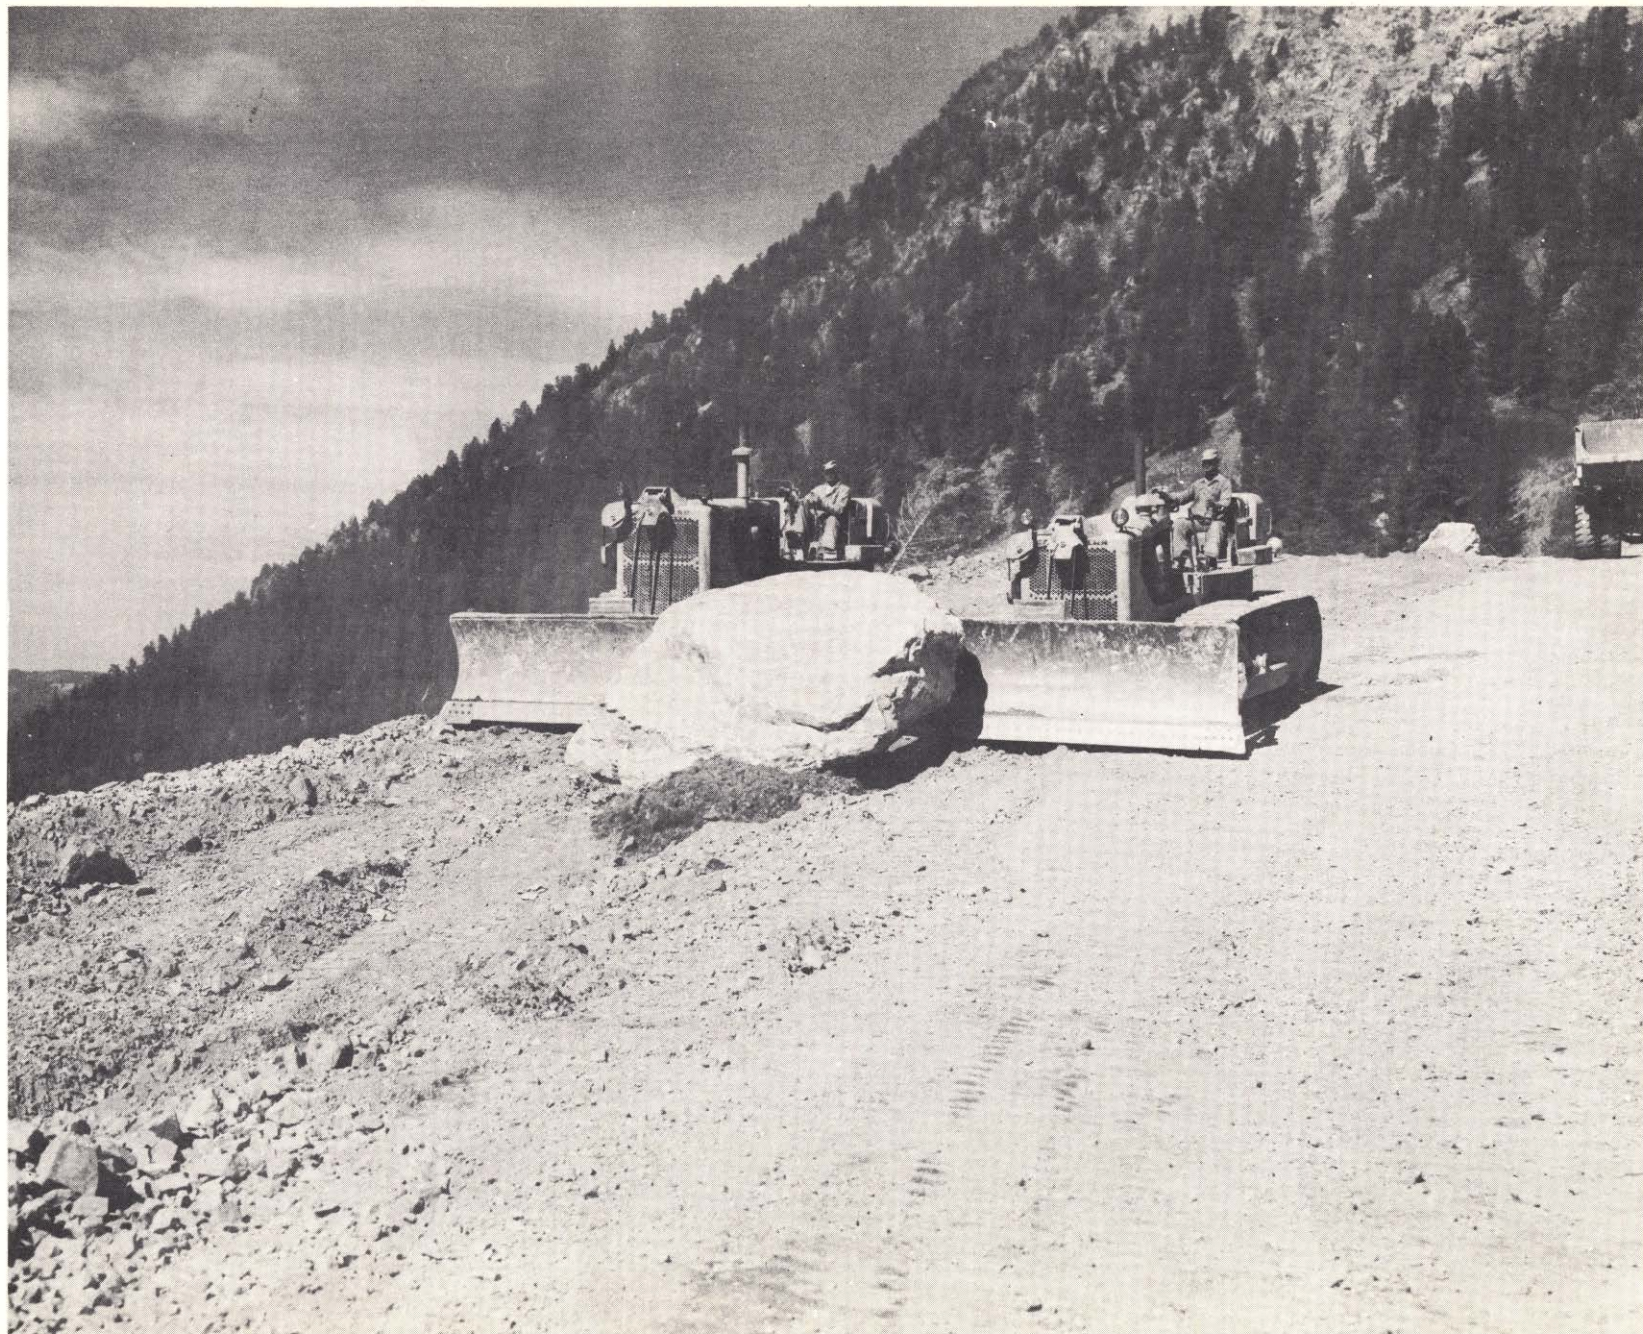
Photo 10. 11 September 1959. Two bulldozers pushing large rock.

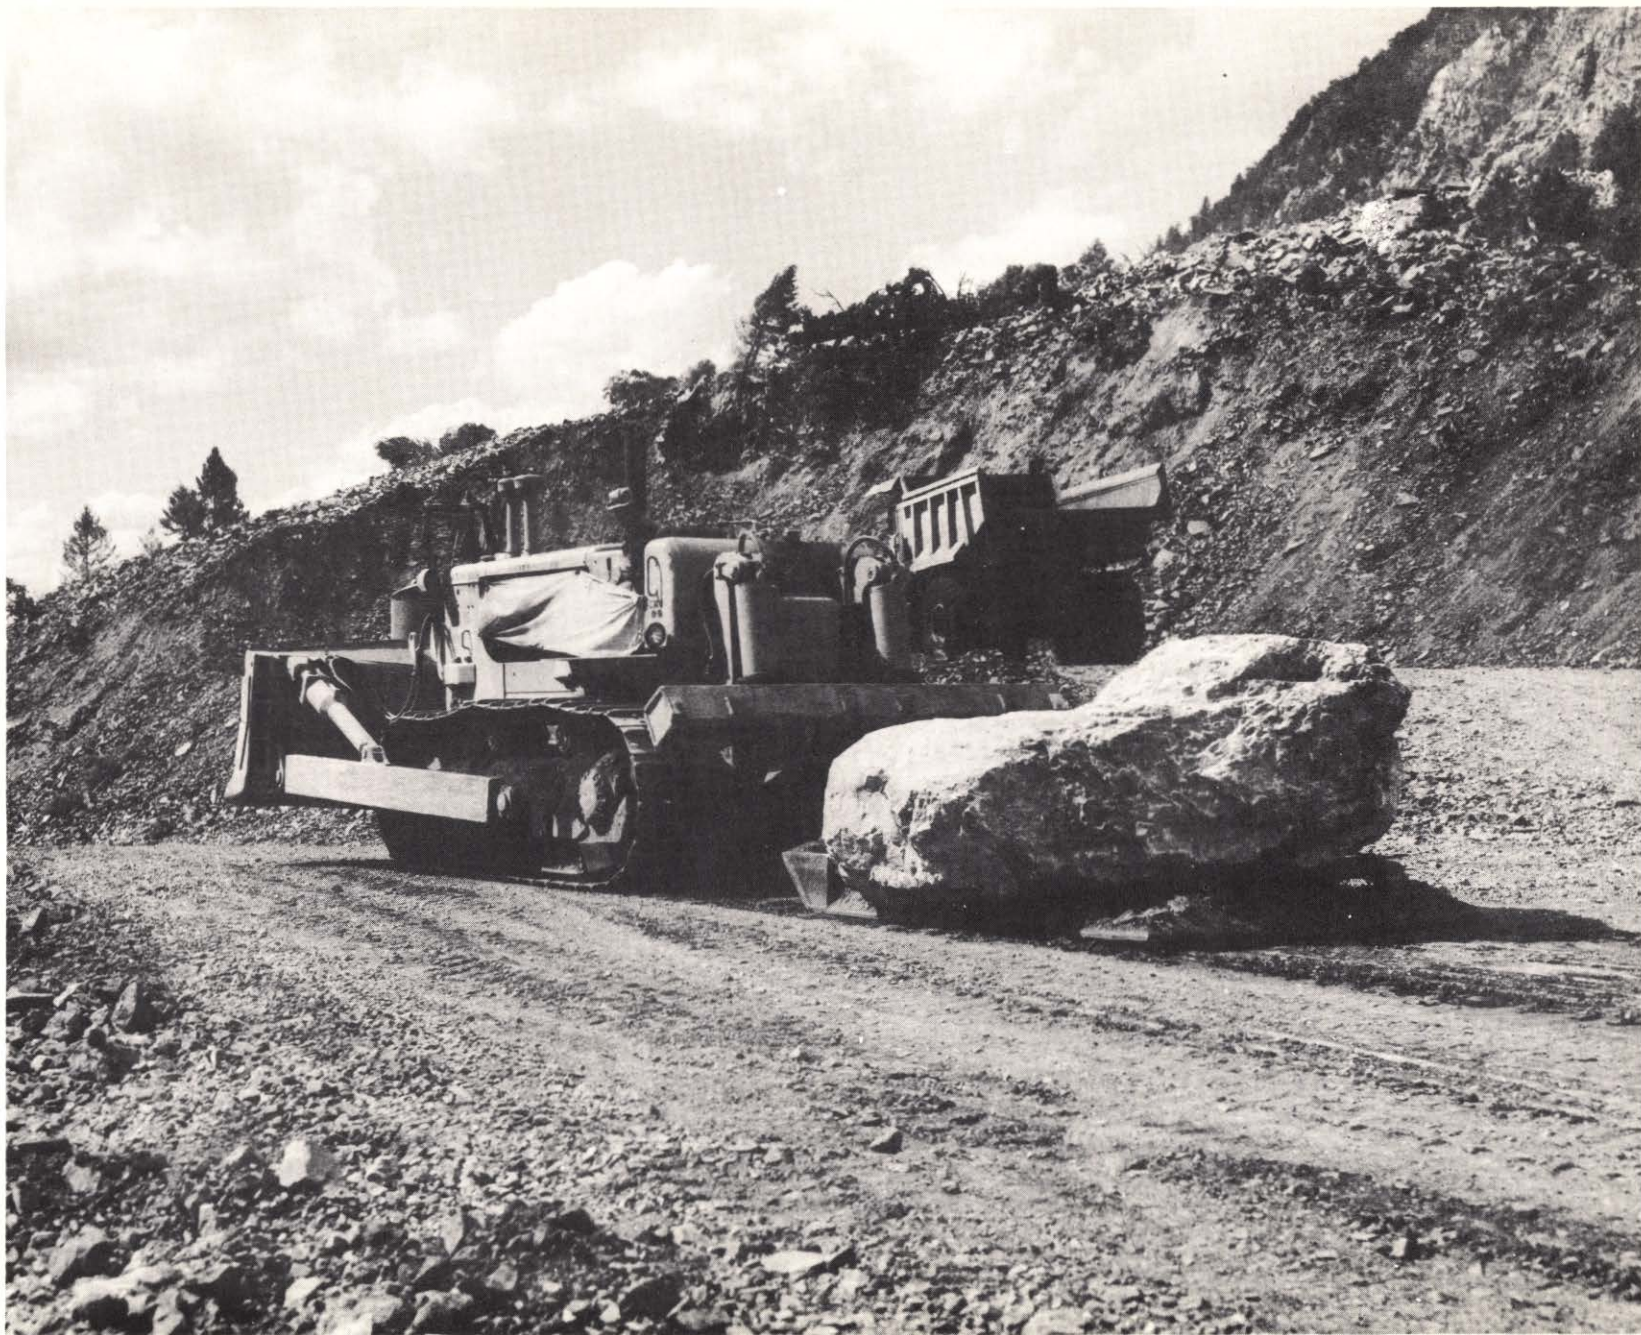
Photo 11. 16 September 1959. Tractor pulling large rock on rock sled.

under the slide. Drilling was started on 3 September, using a churn drill with a drive barrel, so that samples of materials could be recovered. Rock bits were used occasionally, but only when necessary, since their use permitted the recovery of samples only by bailing the mud sludge at the bottom of the holes. In all, six piezometers were installed along the right side of the spillway, though not all were observed concurrently. The locations and observation records of the piezometers are shown on plate 15. Full details of drilling are contained in Appendix X. In general, the observations showed that early conclusions drawn from surface inspections were in error. The earth and rock-floor fines were distributed throughout the major portion of the slide mass. Note material shown in photographs numbers 11 and 17.

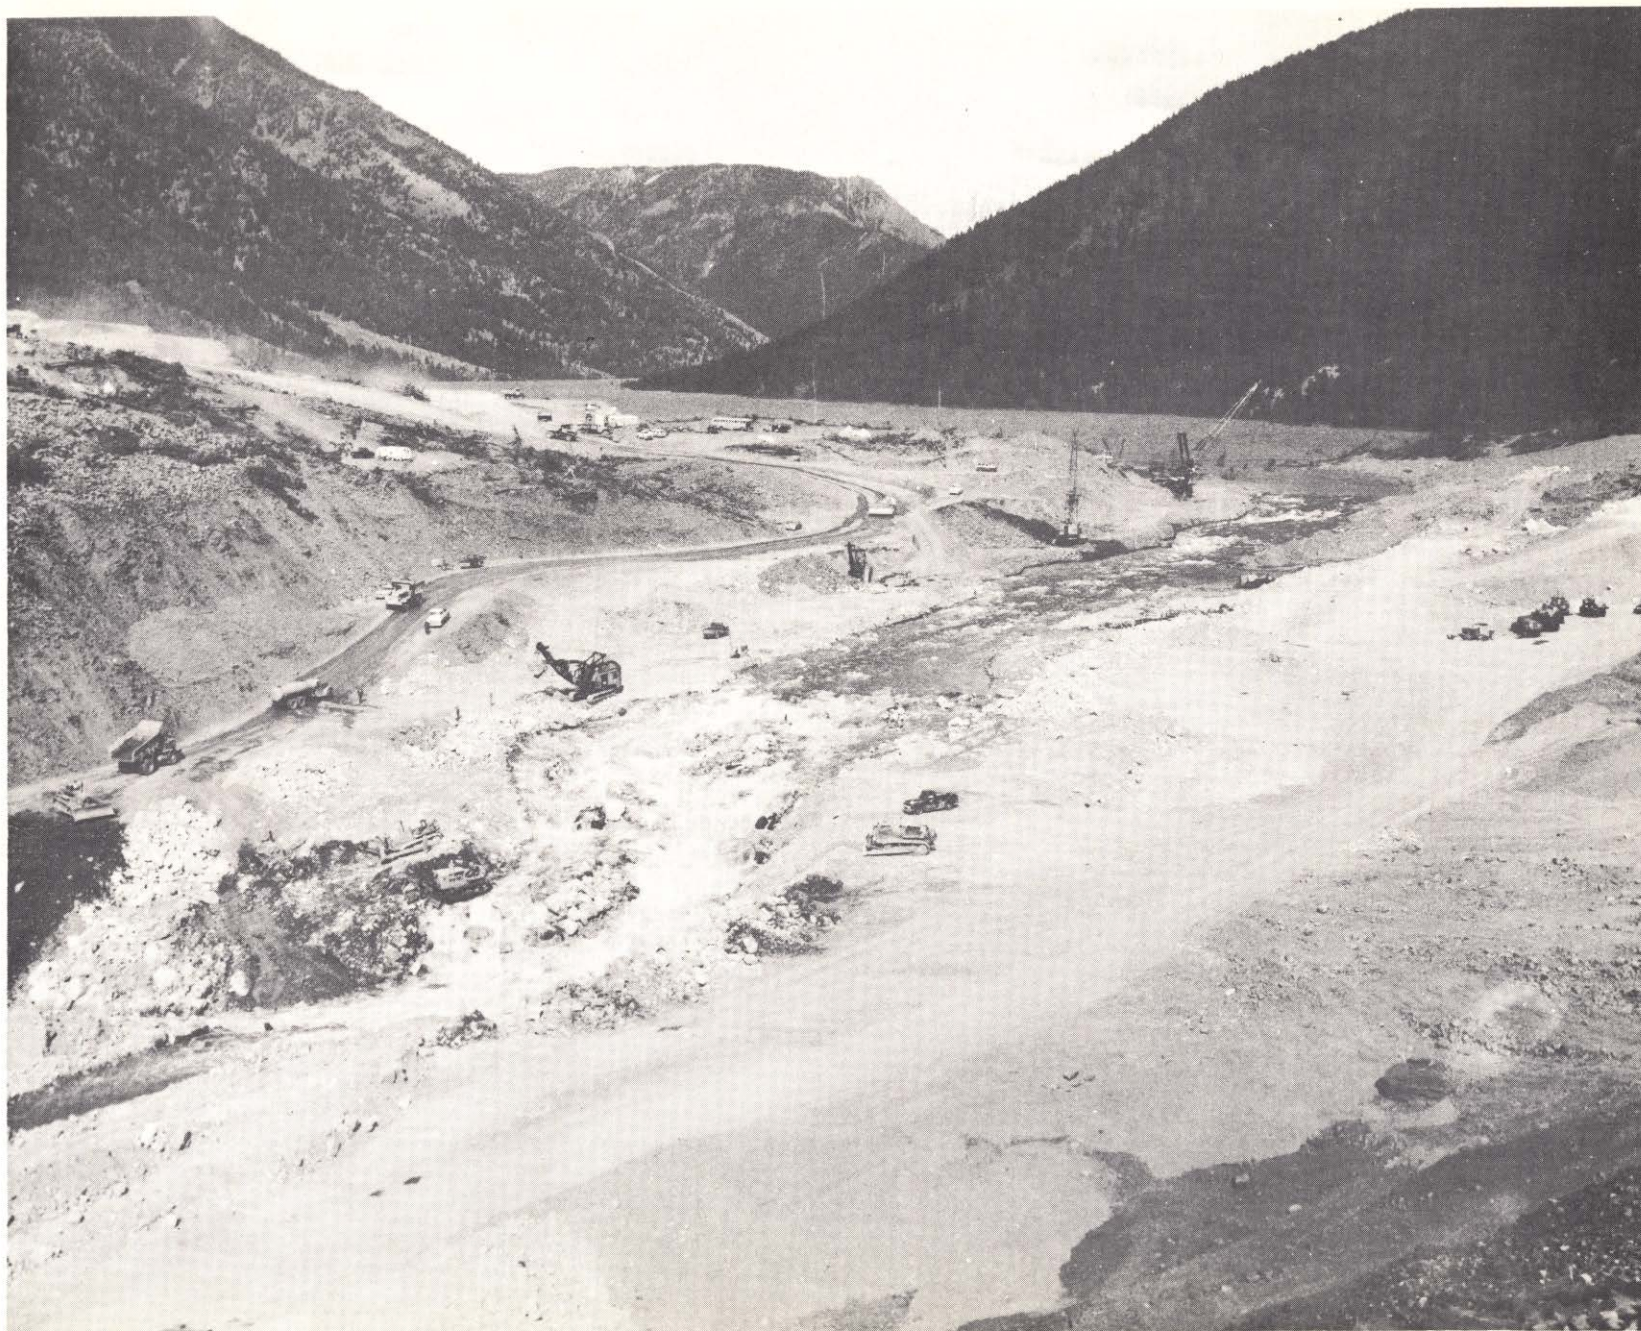
Photo 16. 5 October 1959. General view of spillway lowering operation. Draglines are working in channel and shovels are maintaining a work berm.

58. Lowering of the spillway crest proceeded according to plan. Starting at the spillway entrance and working from a berm just above the water surface along the right side of the channel, the 6-cubic yard dragline moved downstream, making a cut about 50 feet in width and 10 feet or more in depth. Approximately the last 50 feet at the downstream end of each cut, which constituted a broadcrested control weir, was degraded cautiously to prevent a sudden release of the stored water behind it. After this weir or plug was cut down to the elevation of the channel above it, the dragline returned to the channel entrance and started another cycle. The excavated material was loaded into trucks and hauled to waste areas. Meanwhile, the other draglines were working along the channel downstream from the crest, removing the larger rocks and assisting the flowing water to erode the channel and carry the material downstream. Shovels and trucks, working in teams behind the draglines, cut down the working berms progressively, so that the draglines were always working just above the water.
